Mill Creek Stewardship Rangers

Final Report 2015

Prepared by: Adam Riggi, Mill Creek Crew Leader (GRCA)

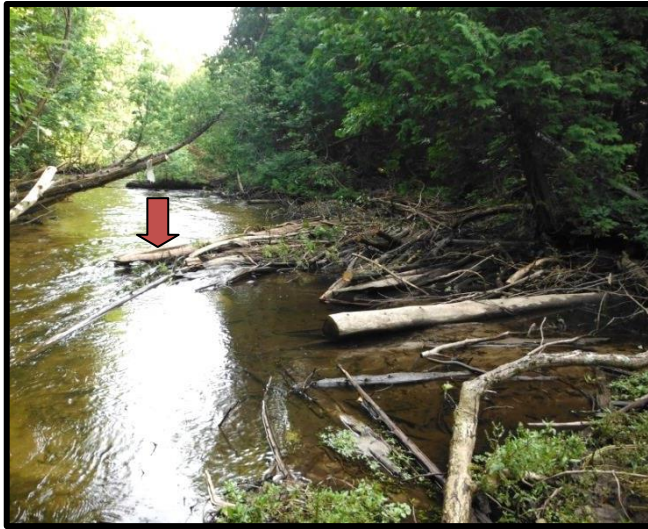
Modification # 1

The deflector seen in photo 2 was built to push the thalweg left of center looking upstream. It was noticed that water was flowing around the base of the structure and supplying a channel behind the deflector chosen to be cut off last year. Photo 3 demonstrates the Rangers' work this year to combine cedar foliage and logs to block off the flow to help stabilize the area and encourage the appropriate deposition of sediment. **(Red arrow indicates landmark)**

Photo 2 - Structure from last year

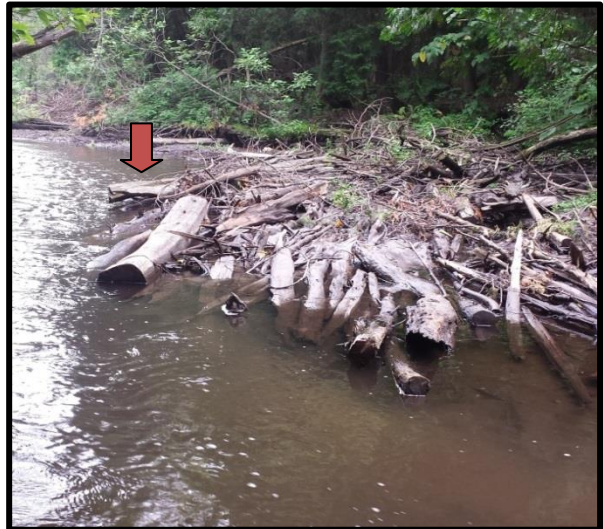
Photo 3 - Structure after modification

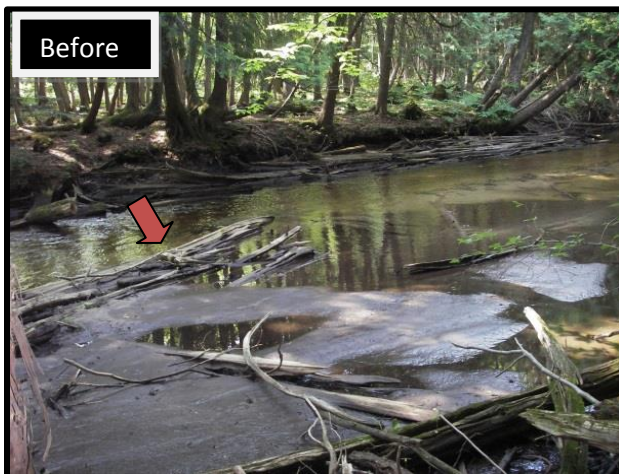
Modification # 2

Since last year, the area behind the deflector in photo 4 experienced a great deal of sediment accumulation. To encourage further sediment deposition in this area, a new structure was built (photo 5). It's anticipated with time a more continuous stream bank will establish to maintain the narrowing channel profile.

Photo 4 - Structure from last year

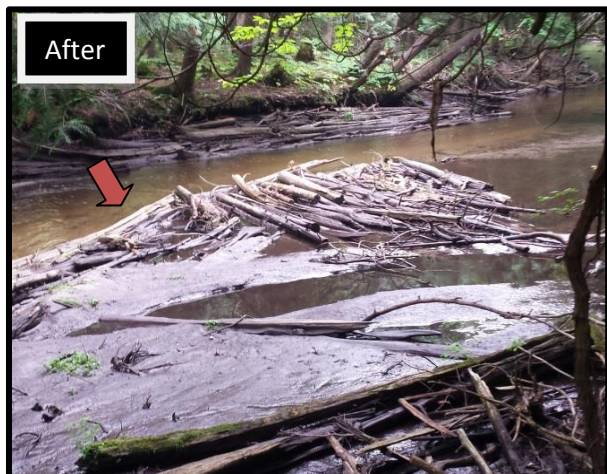
Photo 5 - Structure after modification

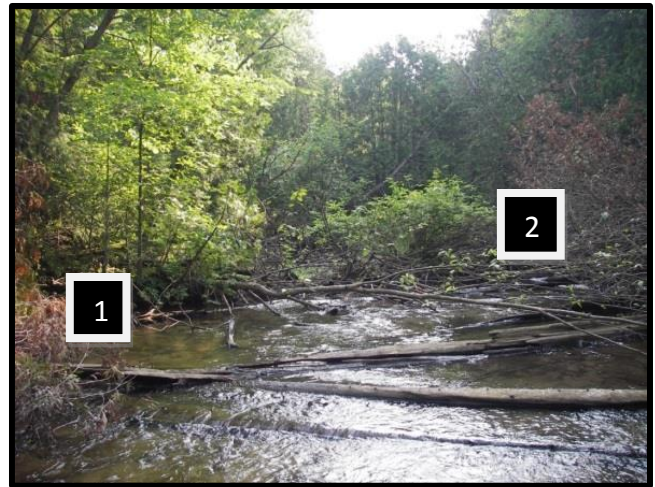
The first logjam cleared by the crew (Photo 6) was located between structures 1 and 2. Most of the logs had fallen perpendicular to the stream and forced the channel to flow very wide. The Rangers cleared all of the submerged logs, some of which had diameters of greater than 30cm. Once all of the debris was removed, the new thalweg could be observed. The stream immediately began to cut a narrower and deeper channel profile making it easier to distinguish the thalweg and an estimation of where to position structure 1 could be made. The sweeper structure was constructed to protect the bank from erosion, to promote deposition of sediment and to provide habitat. Material was used from the cleared logjam and cedar foliage was gathered to create the structure. After the installation of structure 1, the crew noticed that the substrate adjacent to the structure had changed. The once sandy and silty substrate was flushed downstream, uncovering the gravel substrate. The Rangers also observed changes in water depth within the channel and a well-defined pool and riffle section was observed upstream and downstream of the structure.

Photo 6 - Logjam removed by the rangers (numbers represent the relative locations of where structures were built).

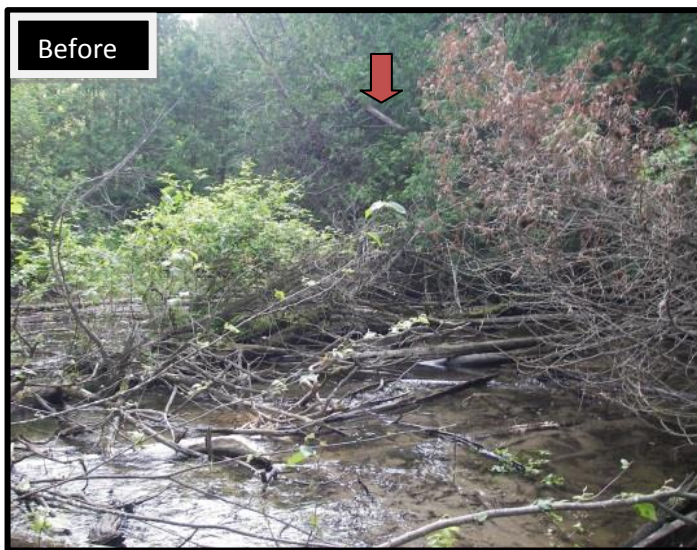
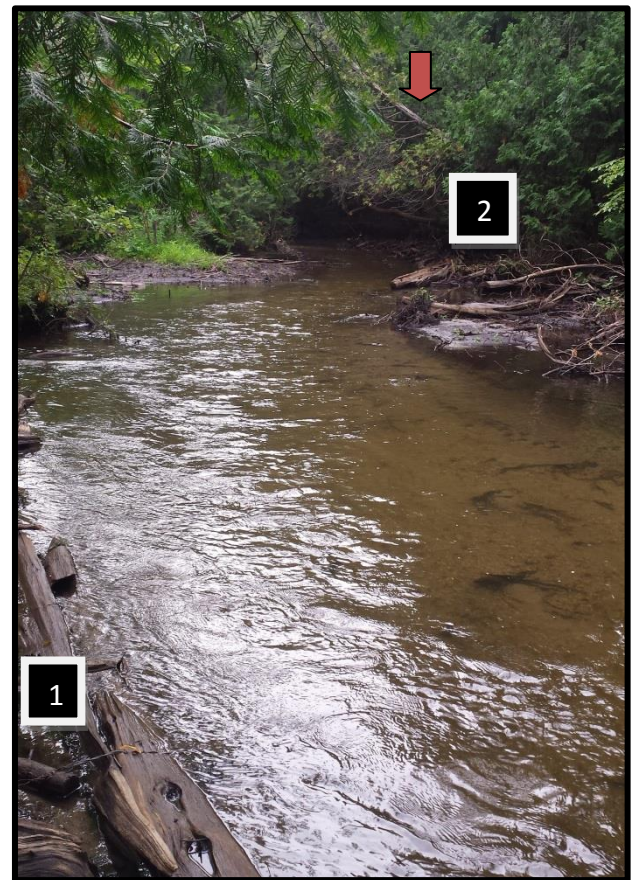
Removing the first logjam resulted in significant changes upstream. The section of stream between structures 1 & 2 narrowed dramatically (photos 11 and 12). The crew planned on constructing a deflector upstream of structure 2 which would re-direct flow downstream. Anticipating an increase in flow velocity, the Rangers built a sweeper structure to protect the stream bank from erosion (photo 13). The active channel width was reduced by 50% and encouraged the transport of sediment downstream. Initially most of the substrate in the work area was sandy and the channel depth was less than 15cm. Within a week the channel depth deepened to approximately 70cm towards the upstream end of structure 2 (photo 17).

Photo 11 - View looking upstream before logjam removal

Photo 12 - Channel response to removal of first logjam

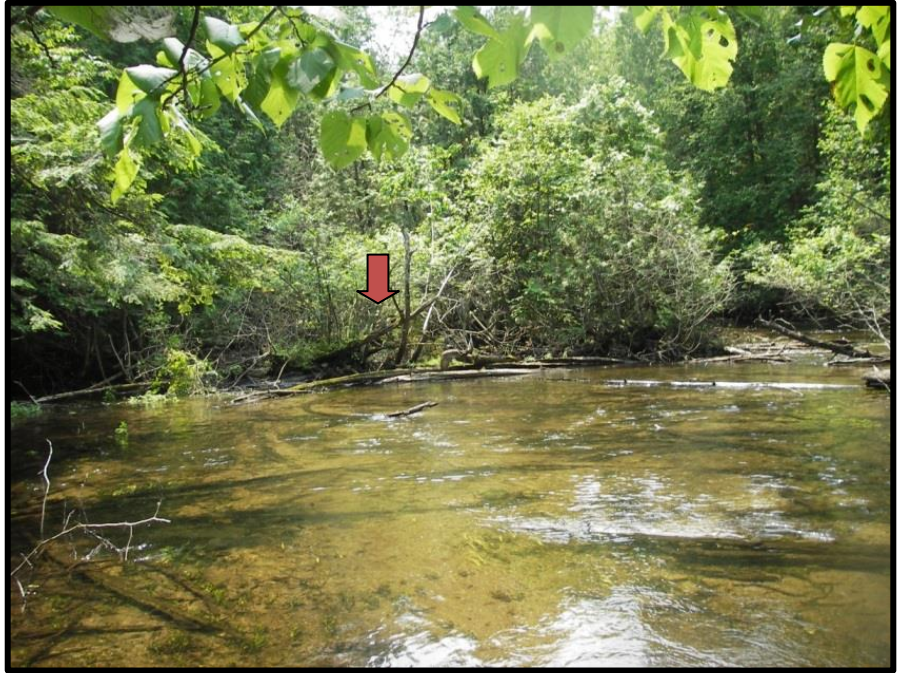
A wide and braided channel is not the natural channel type for the reach of Mill Creek flowing through the Lake's property. Photo 18 is an example of how a blockage can disrupt the natural meander pattern of a stream. Since there were two active channels present, the Ranger crew had to evaluate which channel to block off. The Ranger Crew decided to direct the stream channel left of center (photo 18) by installing a deflector structure to block off the undesired channel.

Photo 18 - Braided channel looking downstream before restoration

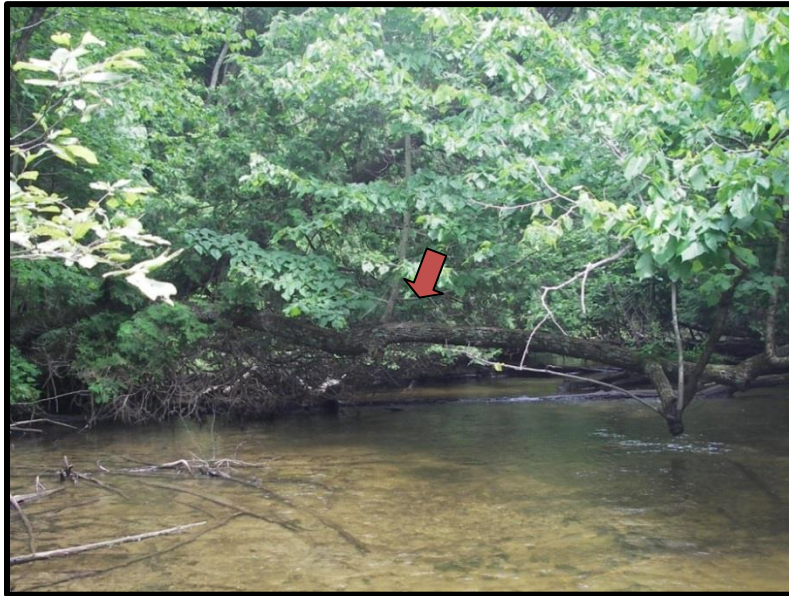
With all of the downstream structures constructed and secured, the Rangers tackled another formidable logjam (photo 23). They were able to remove the logjam in a single day during a joint work-day with the Ontario Ministry of Natural Resources and Forestry Stewardship Rangers. Predicting which way to divert the stream was made easier by consulting the downstream meander pattern already established.

Photo 23 - Logjam upstream of structure 3

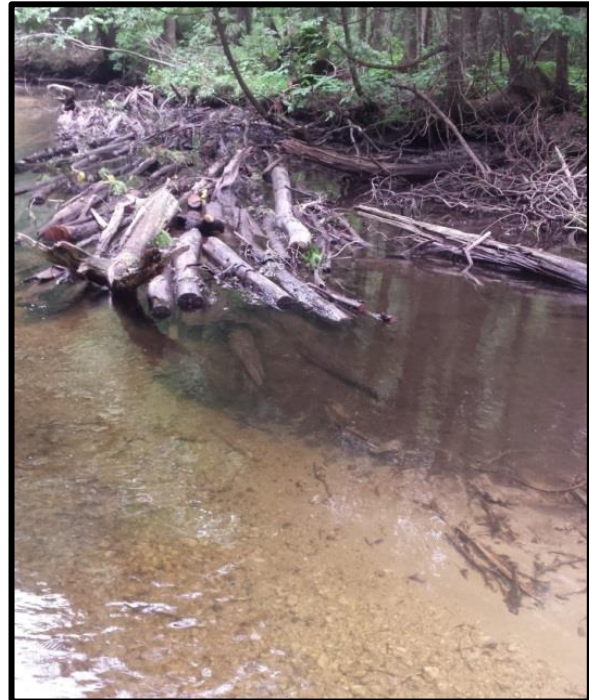
Reduce the cross sectional channel width by 50%. The area behind structure 5 is no longer part of the active channel and sediment has already begun to accumulate (photo 30).

Photo 30 - Sediment accumulation behind structure 5

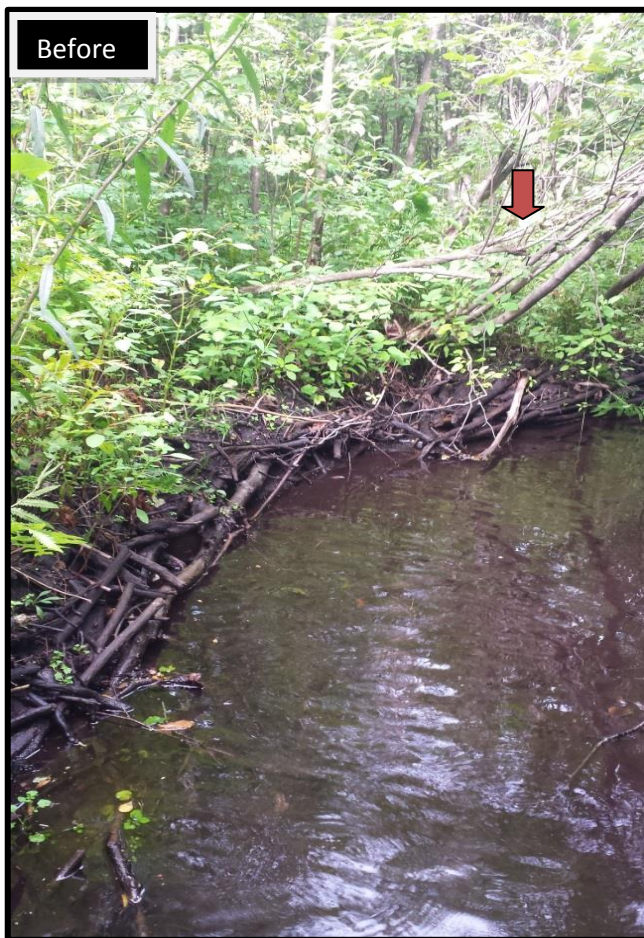
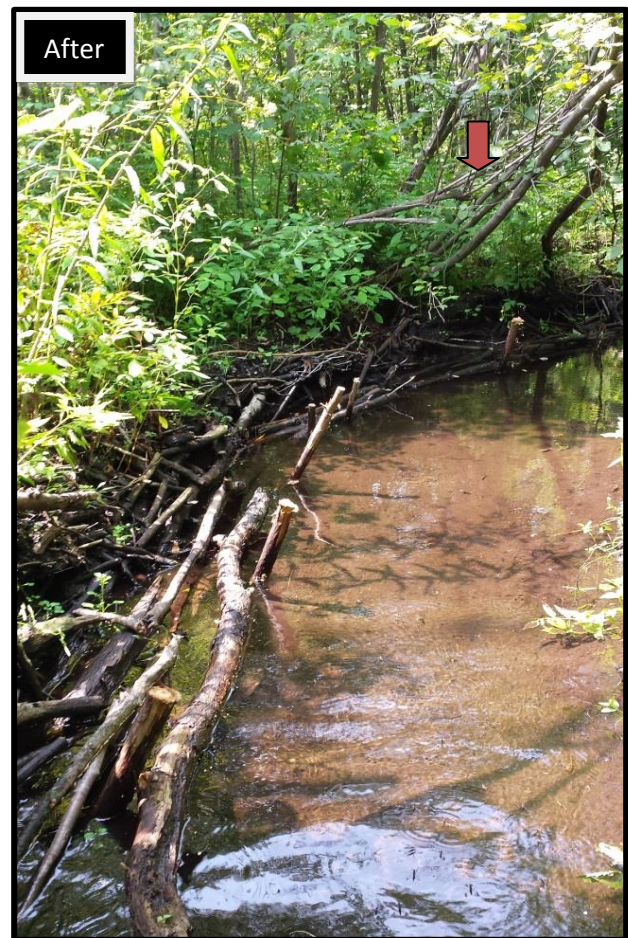
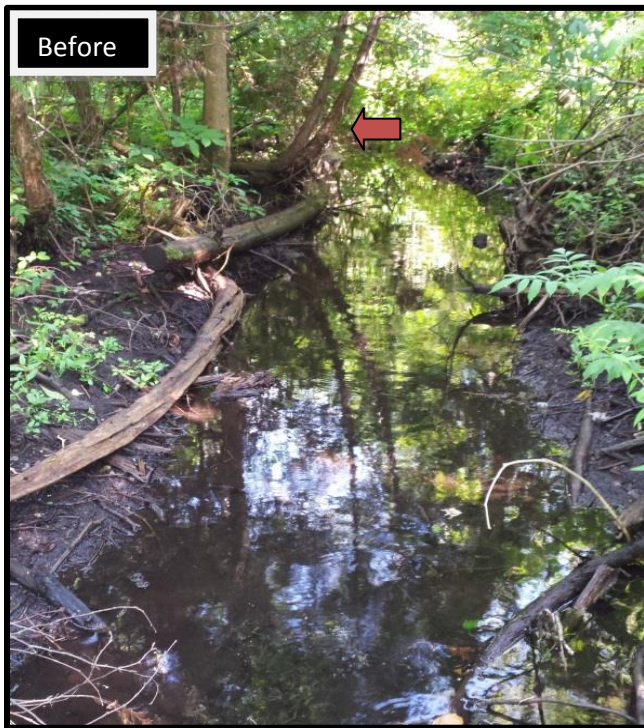
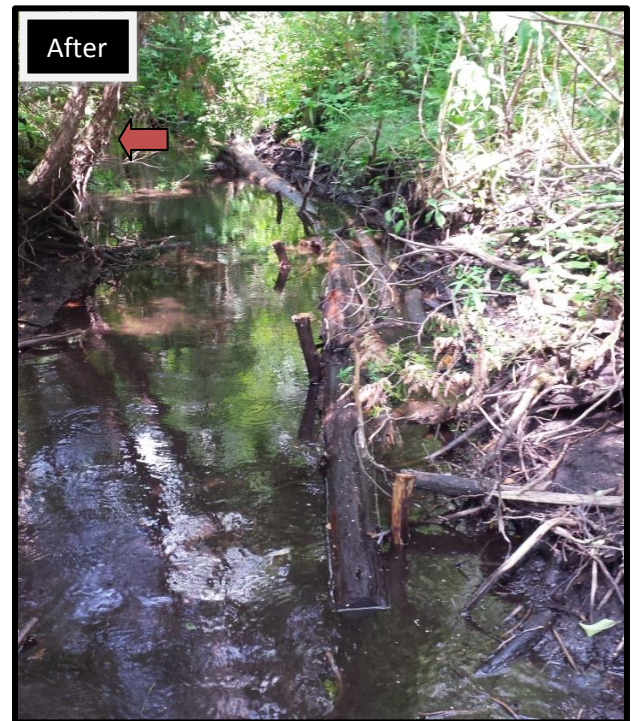
The first step at this property was to inspect the work done by last year's crew and it was noted that most of the woody debris installed last year had moved. This year's objective was to improve the location of the woody debris placed in the stream and secure it properly. This was accomplished by re-positioning the material back into strategic locations that would provide habitat for the brook trout. With permission, freestanding dead cedar trees, approximately 5cm in diameter, were cut to lengths of roughly 75cm. Cedar stakes were driven into the ground in front of the newly placed debris in order to prevent the logs from floating away. It took the crew 2 full days to modify the entire 350m of stream that was cleared by last year's crew. Photos 31-34 demonstrate the modifications:

6. Further restoration work at Wozniak's Farm Property should proceed after a complete survey of the section treated by this year's crew is completed. Structures placed in-stream were anchored using a new method and should be checked for movement. Also, depending on the amount of sediment that has moved, woody debris might need to be re-placed closer to the thalweg to provide habitat for the brook trout.

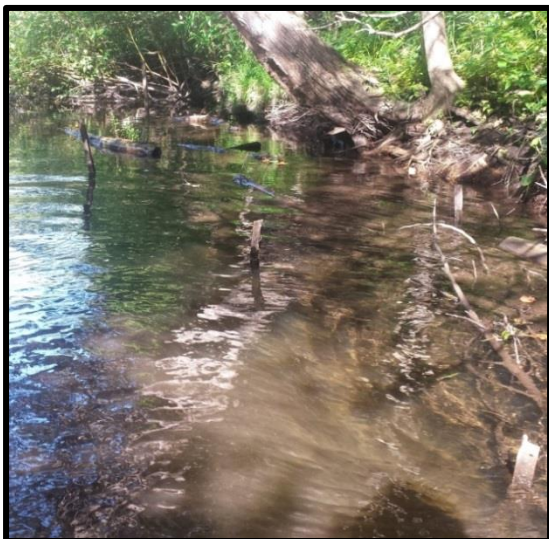
Even before the Mill Creek Stewardship Ranger Program had been founded, members of the GRCA were carrying out Mill Creek restoration activities at the Bond Tract property. Prior to earth anchor technology, it was common to use steel T-bars to secure deflector and sweeper structures. The T-bars at this location had served their purpose and it was time for their removal. As the structures were now established, there was no concern about them failing because most of the woody debris and sediment deposition had naturalized. However many T-bars now stuck out of the water and posed a potential hazard to anglers and hikers. The T-bars also looked very foreign within the landscape.

Photo 35 - Typical section of creek with T-bars

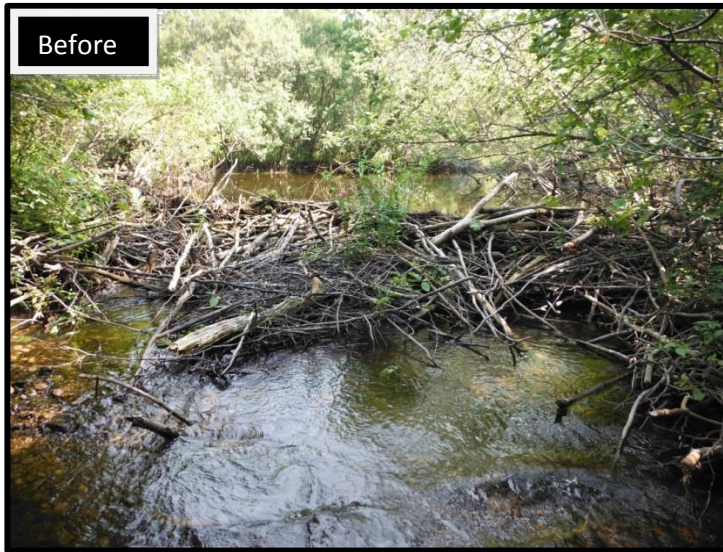
Dufferin Aggregate Pit and the Heritage Lake residential community were two additional properties identified in the Rangers' summer workplan. At both locations, beavers had built dams across the entire Mill Creek channel resulting in the impoundment of water. Although beaver activity is a natural phenomenon within the Mill Creek watershed, the dams had to be removed for monitoring purposes. Flow gauges, temperature monitors and groundwater measuring devices are located in these areas in order to collect data. Industry and regulatory bodies in the region rely on these data to quantify any potential influences industries may be having on the environment. Beavers had raised the water level approximately 80cm above the dams at both locations.

Photo 38 - Beaver dam

It took 2 days to remove the dam completely. The first day 50% of the material was removed and the crew had to make sure to do so evenly across the top of the dam to prevent a failure. A week later, the Rangers returned when the water levels had dropped which allowed the removal of the remainder of the dam. Most of the sticks were intricately woven together and it was quite difficult to dismantle. The sticks were displaced up on shore away from the dam location so it would not be easy for a beaver to resemble.

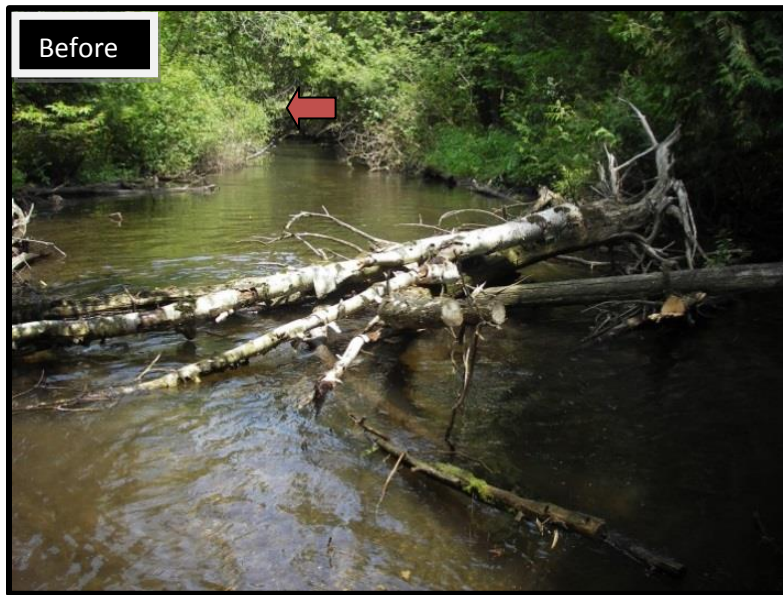
Debris removal and habitat improvements were also assessed downstream of the dam. A smaller debris pile was dismantled and rearranged towards the right hand side of the stream. This allowed sediment to be carried downstream and the new structure provided habitat.

Photo 42 - Debris pile downstream of the beaver dam

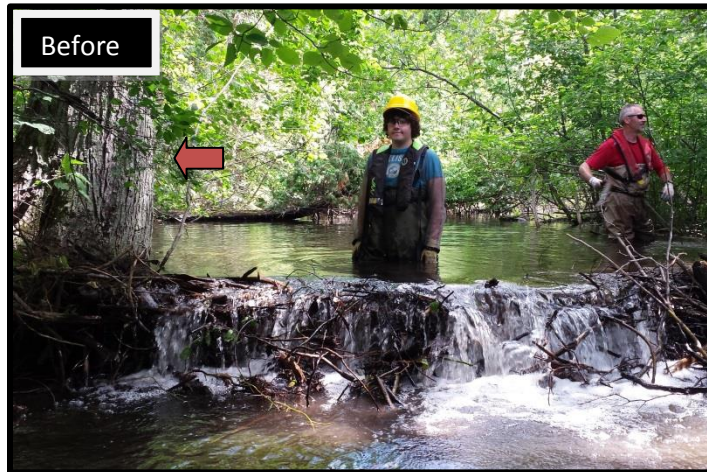
It was a trek to find the location of the dam, but after a few bee stings and a swift jog, the Rangers were able to locate it. The dam was smaller than the one dismantled at Dufferin and could be removed within a day.

Photo 44 - Initial water level with beaver dam

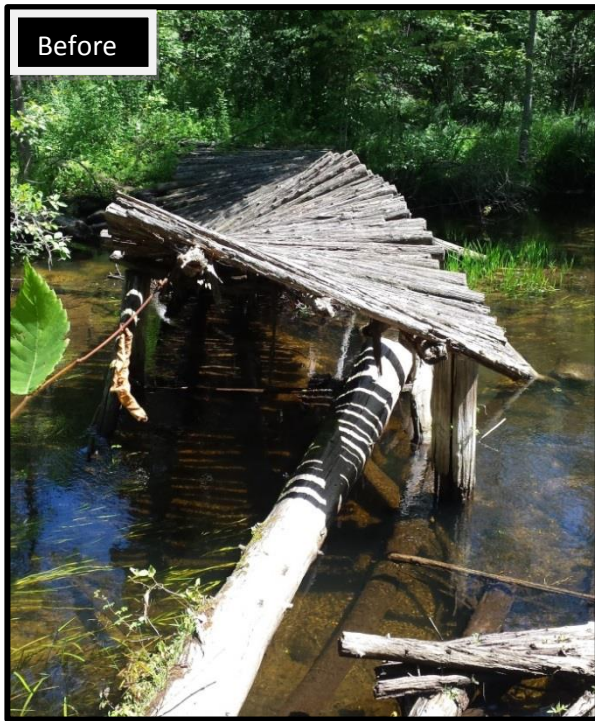
Photo 46 - Old bridge

A total of 1½ days were spent at this property removing woody debris. The first task was to remove an old bridge from the stream because it was obstructing stream flow and was a potential source of further debris. Most of the cedar logs used on the top of the bridge were easily removed and piled up on shore. The remaining structural frame was built out of some very large logs and it required the whole crew to carry them up onto the shore. Upstream of the bridge, a large tree had fallen into the creek. To prevent excess widening of the creek, the tree was cut apart using hand saws and redistributed along the shoreline to enhance habitat.

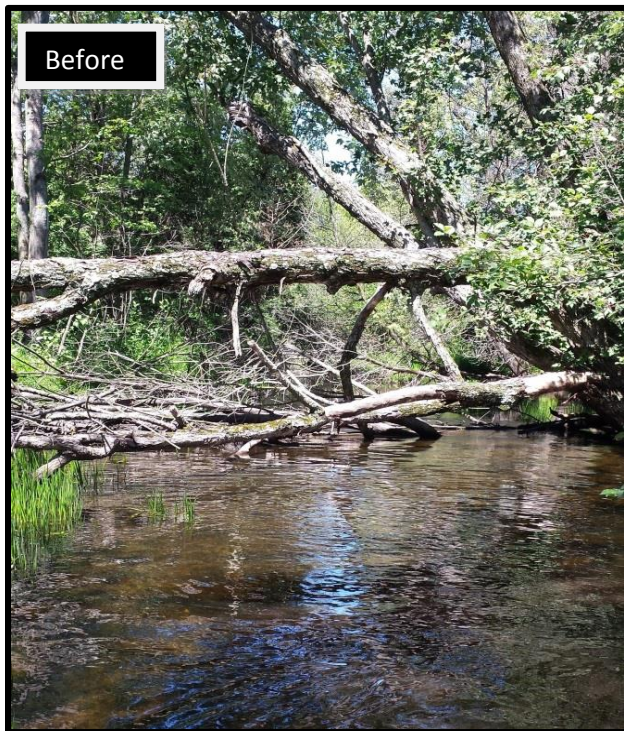
Photo 49 - Large in channel obstruction
