Mill Creek Stewardship Rangers

Final Report 2015

Prepared by: Adam Riggi, Mill Creek Crew Leader (GRCA)

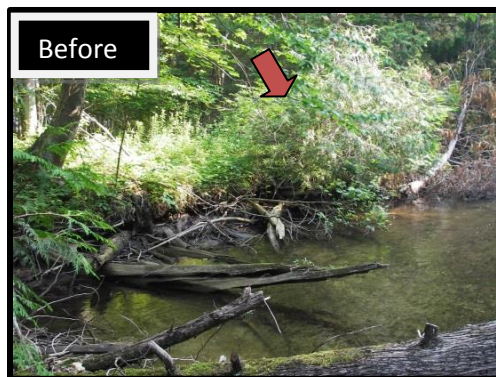
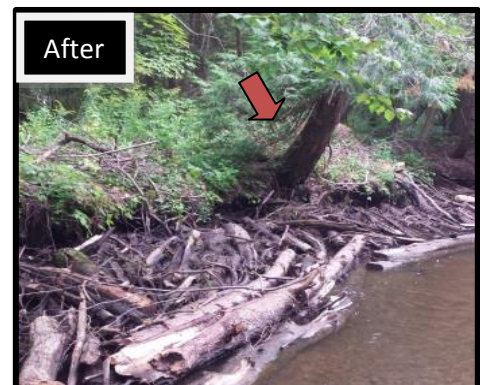
The first logjam cleared by the crew (Photo 6) was located between structures 1 and 2. Most of the logs had fallen perpendicular to the stream and forced the channel to flow very wide. The Rangers cleared all of the submerged logs, some of which had diameters of greater than 30cm. Once all of the debris was removed, the new thalweg could be observed. The stream immediately began to cut a narrower and deeper channel profile making it easier to distinguish the thalweg and an estimation of where to position structure 1 could be made. The sweeper structure was constructed to protect the bank from erosion, to promote deposition of sediment and to provide habitat. Material was used from the cleared logjam and cedar foliage was gathered to create the structure. After the installation of structure 1, the crew noticed that the substrate adjacent to the structure had changed. The once sandy and silty substrate was flushed downstream, uncovering the gravel substrate. The Rangers also observed changes in water depth within the channel and a well-defined pool and riffle section was observed upstream and downstream of the structure.

Photo 7 – Location of structure #1

Photo 8 - Structure #1 completed

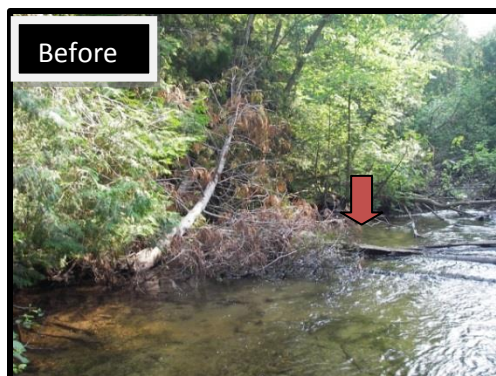
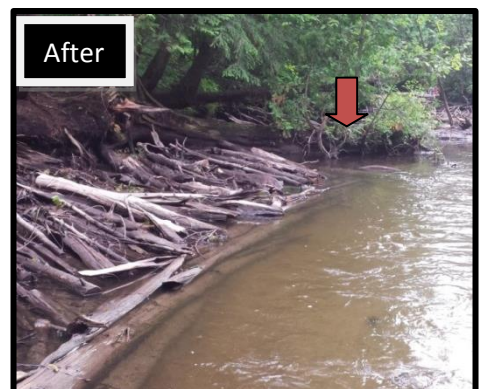
Photo 9- Upstream end of structure #1

Photo 10 - Upstream end of structure #1 completed

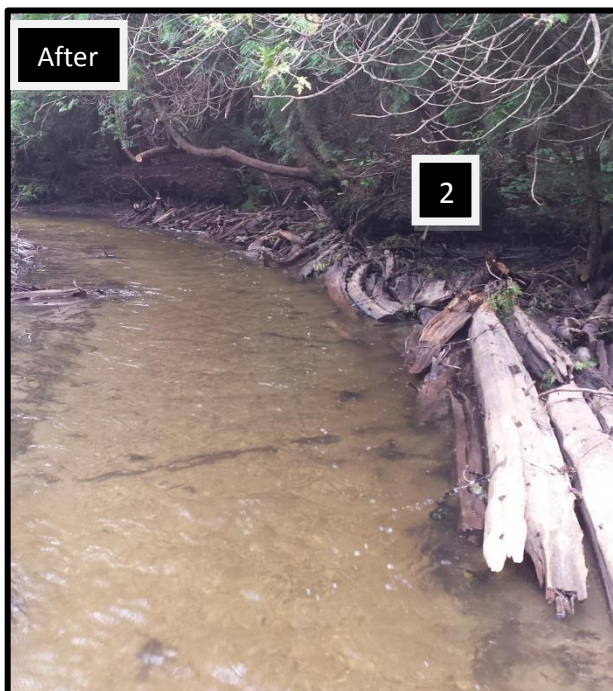
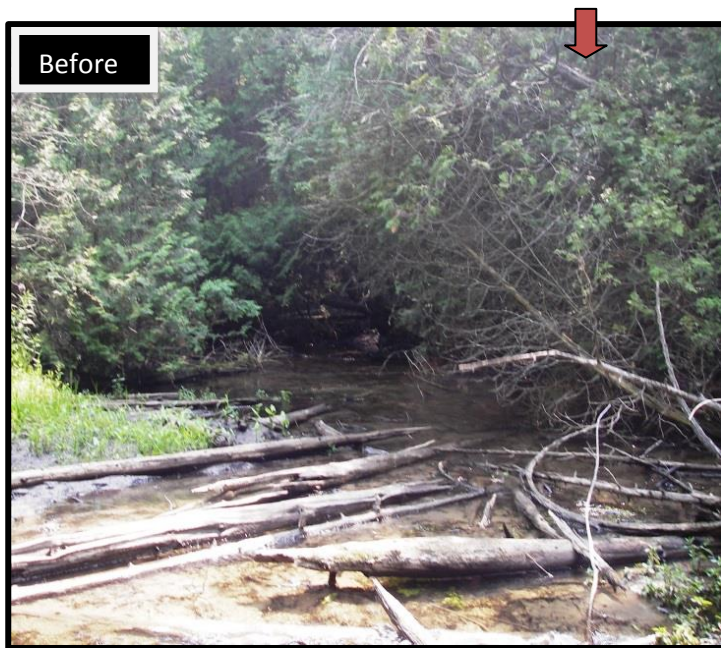
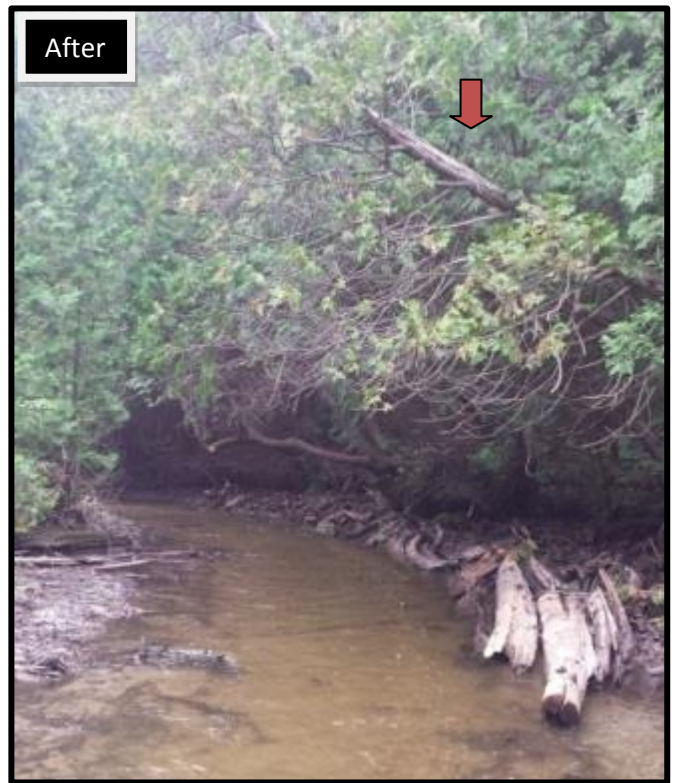
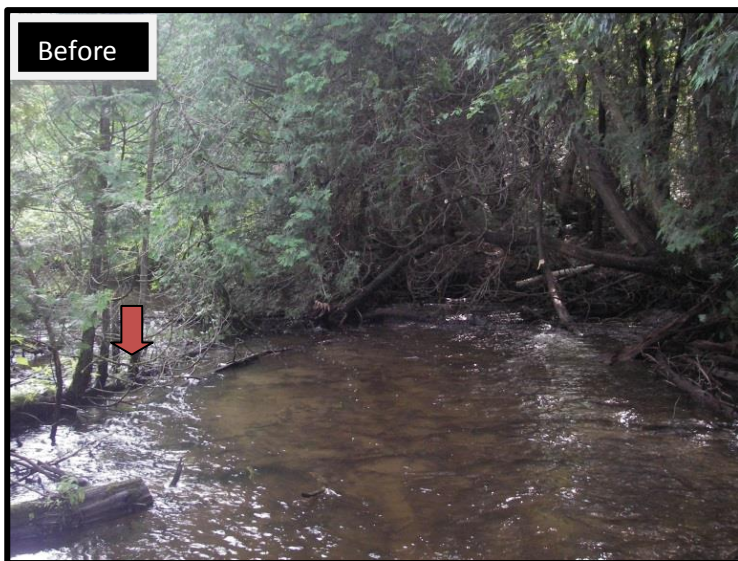
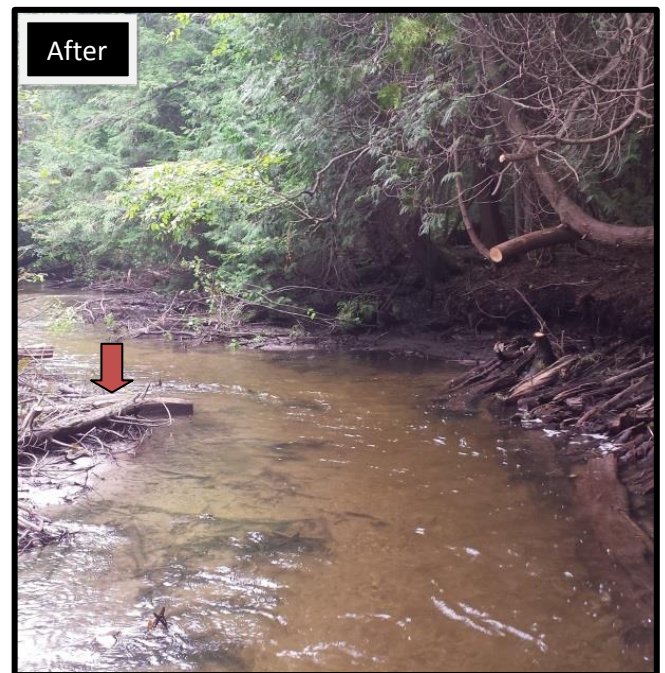
Removing the first logjam resulted in significant changes upstream. The section of stream between structures 1 & 2 narrowed dramatically (photos 11 and 12). The crew planned on constructing a deflector upstream of structure 2 which would re-direct flow downstream. Anticipating an increase in flow velocity, the Rangers built a sweeper structure to protect the stream bank from erosion (photo 13). The active channel width was reduced by 50% and encouraged the transport of sediment downstream. Initially most of the substrate in the work area was sandy and the channel depth was less than 15cm. Within a week the channel depth deepened to approximately 70cm towards the upstream end of structure 2 (photo 17).

Photo 13 - Full view of structure 2

Photo 14 - Location of structure 2 before debris removal

Photo 15 - Structure 2 completed

Photo 16 - Upstream end of structure 2

Photo 17 - Upstream end completed

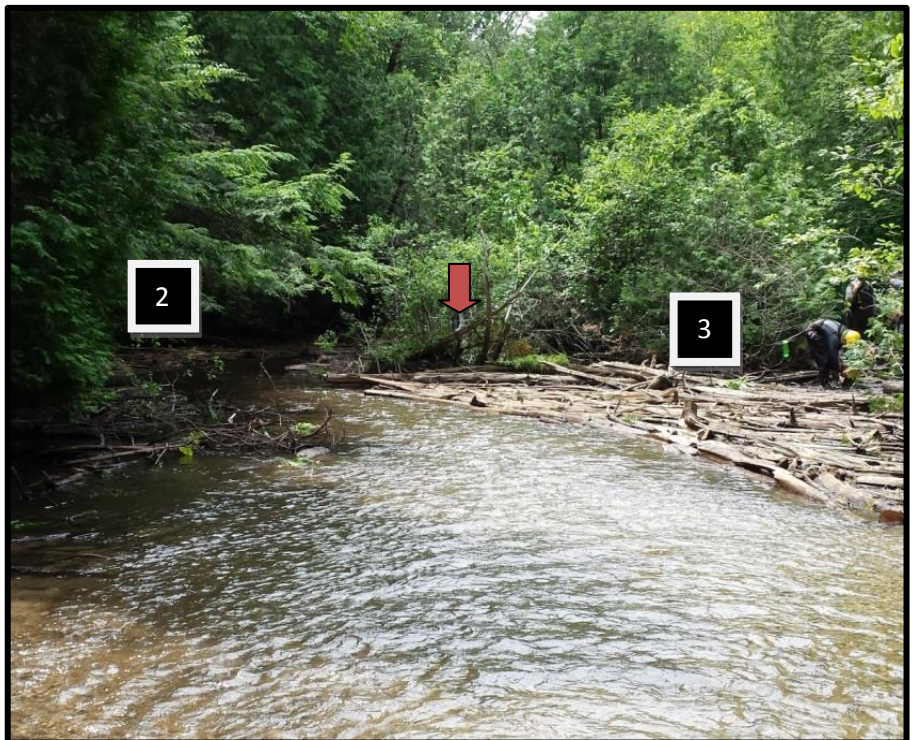
Photo 19 - Channel forced to flow towards structure 2

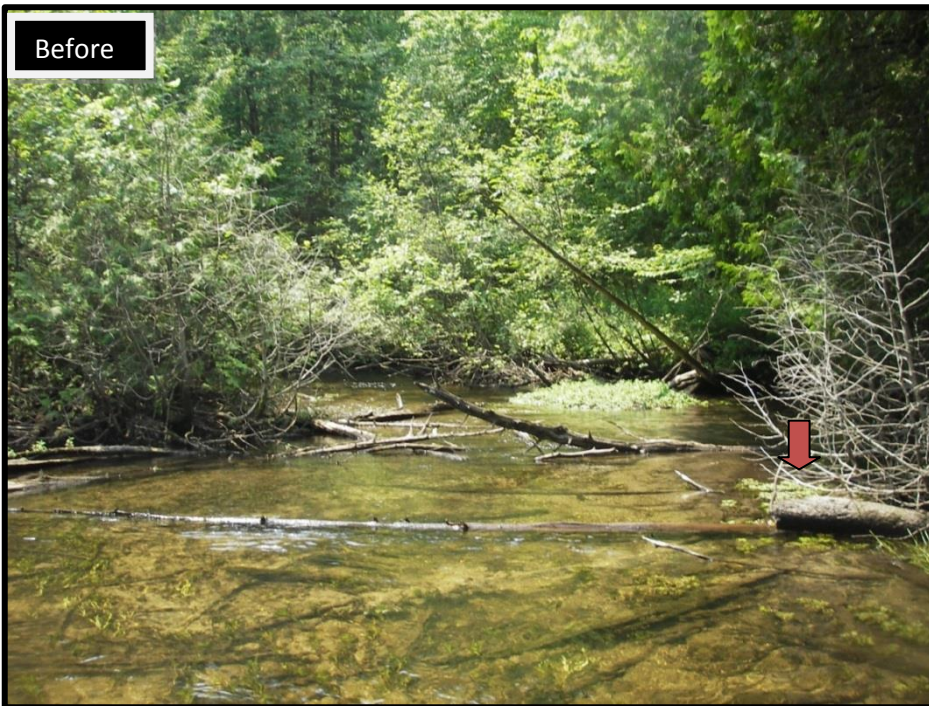
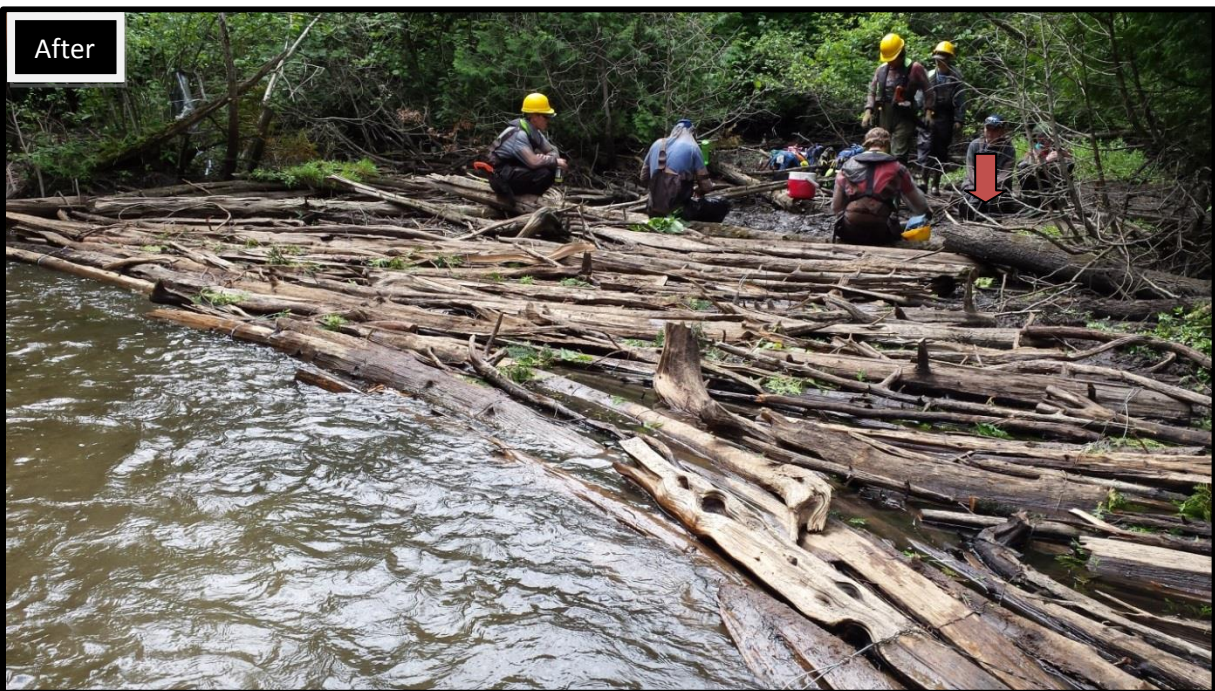
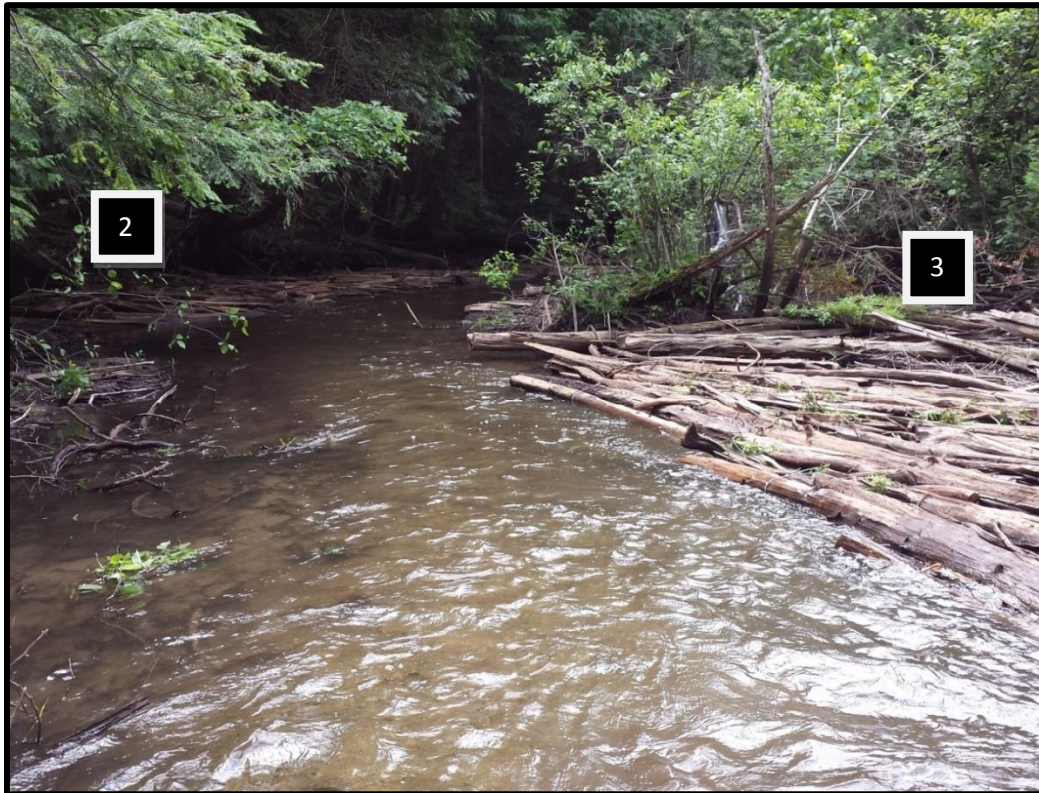
By the time the crew had reached the location for the construction of structure 3, most of the woody debris from the first logjam had been incorporated into the first two structures. The Rangers were able to collect enough material from the streambed and surroundings to build a large enough structure capable of diverting the stream channel. The large deflector structure re-established a more natural meander pattern and cut the cross-sectional channel width by 50% (Photo 22). The thalweg responded to the efforts and a defined channel began to carve its way towards structure 2. Sediment has begun to accumulate behind the base of structure 3 and with time the area should resemble a riparian area and not an active channel.

Photo 20 - Right hand side of braided section looking downstream

Photo 21 - Structure 3 completed

Photo 22 - Natural meander pattern

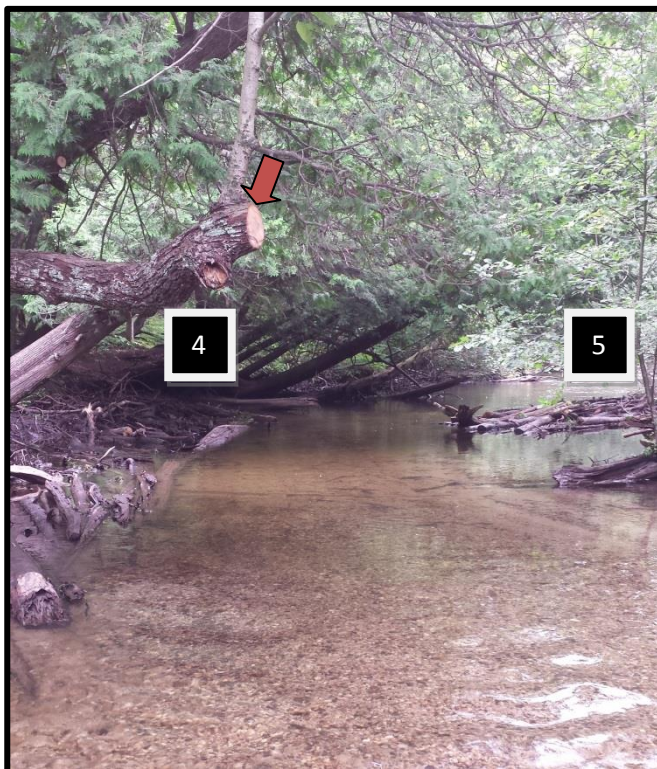
The Ranger crews built a deflector and a sweeper structure; their locations can be seen in Photo 24. Structure 4 was a sweeper structure built to help narrow the channel and provide habitat.

Structure 5 was a deflector structure aimed towards narrowing and changing the direction of flow. Structure 5 was challenging to build for several reasons. The stream was fairly deep so a substantial amount of material was used to effectively push the channel towards structure 4.

Photo 24 – Locations of structure 4 and 5

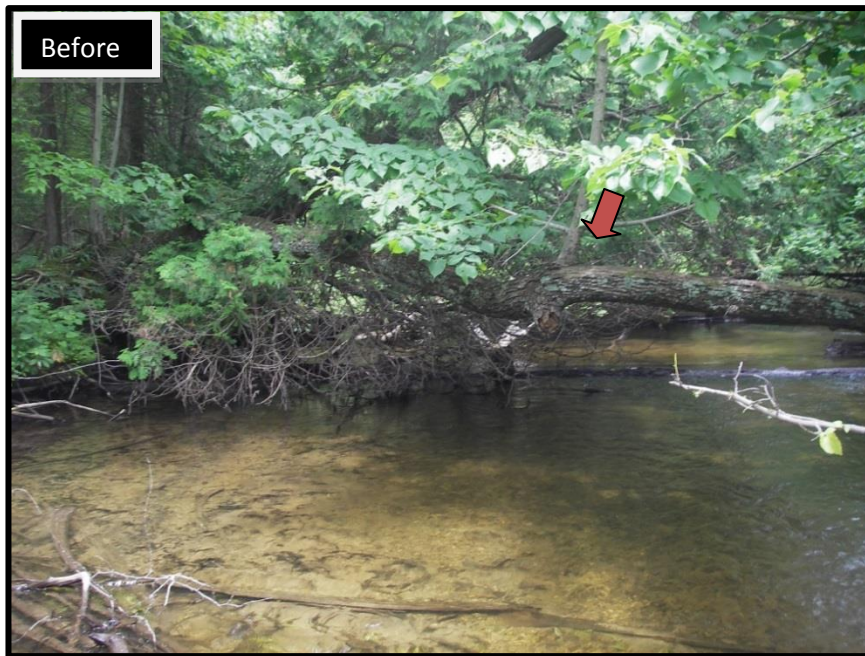
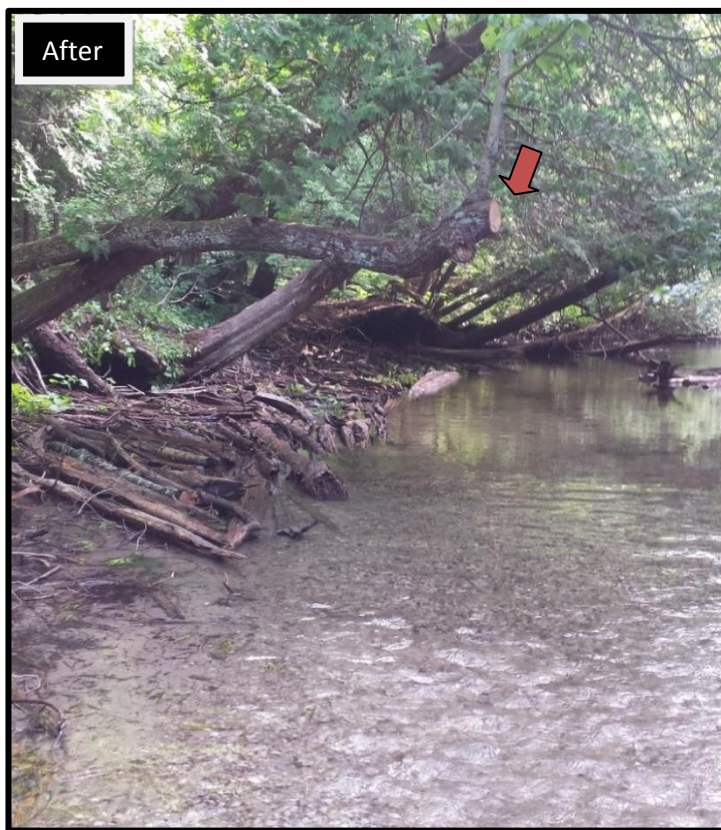
Photo 25 - Location of structure 4

Photo 26 - Structure 4 completed

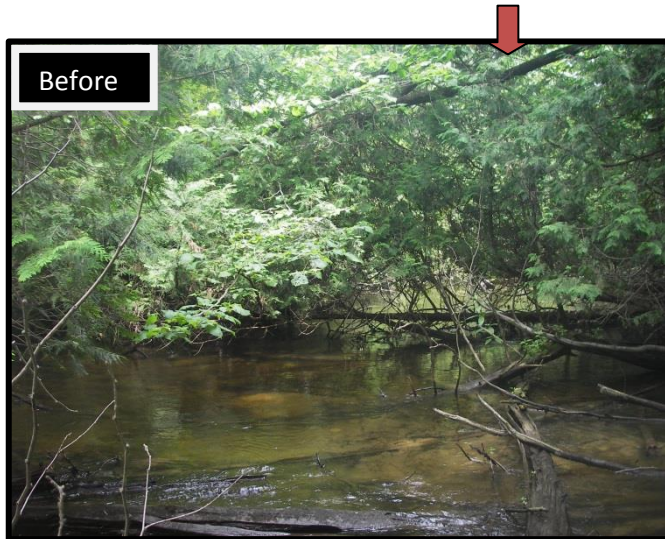
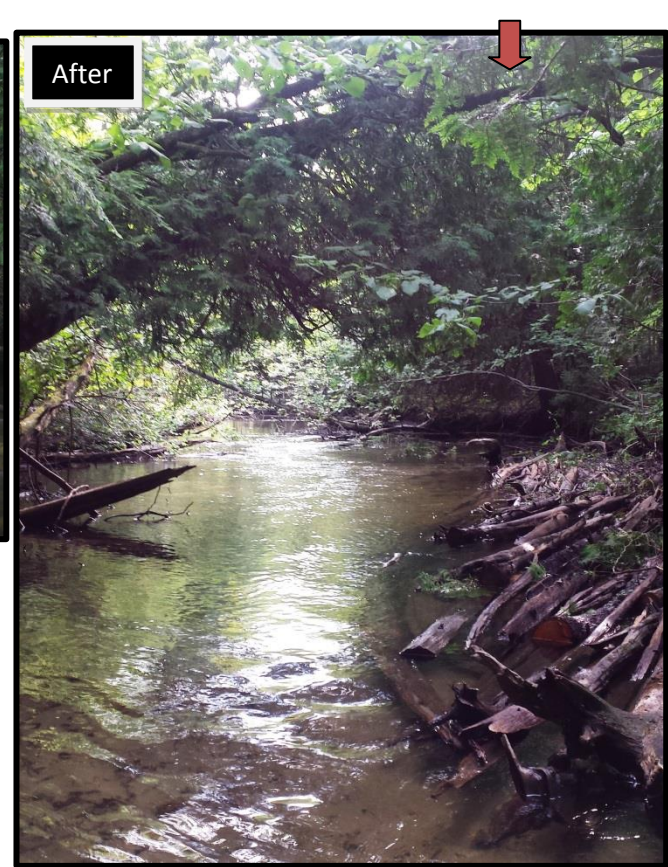
Photo 27 - Location of structure 5

Photo 28 - Structure 5 completed

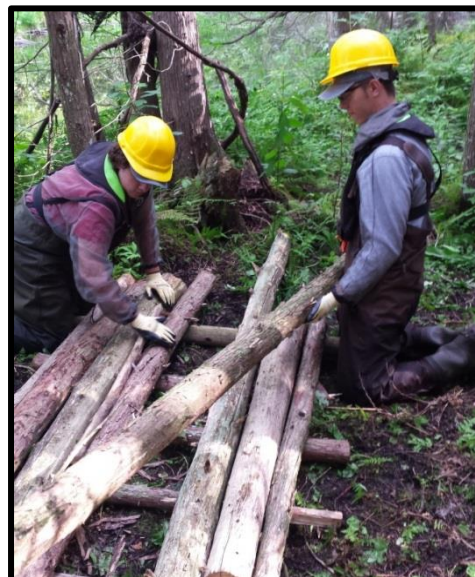
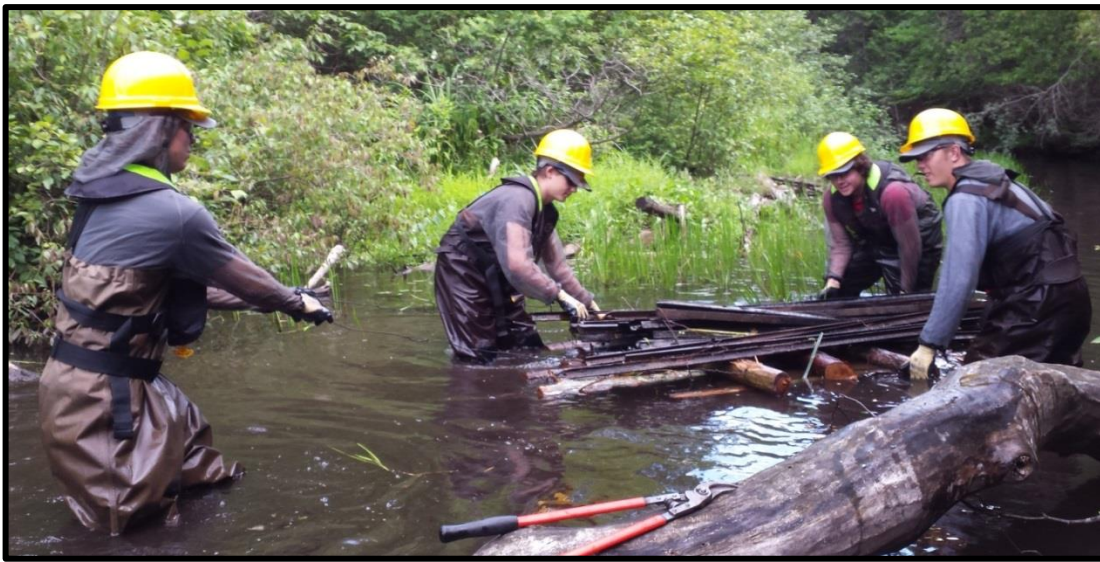
Photo 36 - Rangers building a raft to transport T-bars

Photo 37 - Rangers transporting T-bars downstream towards the truck

The rangers traversed 450m of stream and removed 135 T-bars by hand. Due to the weight and the long distance back to the road, the crew improvised and decided to build a raft to float them out. Dry cedar logs were cut from the surrounding forest and nailed together using large spikes. The raft was approximately 1m x 2m and was able to successfully hold 200lbs of T-bars. In total it took 3 full days to remove all the T-bars from the site.

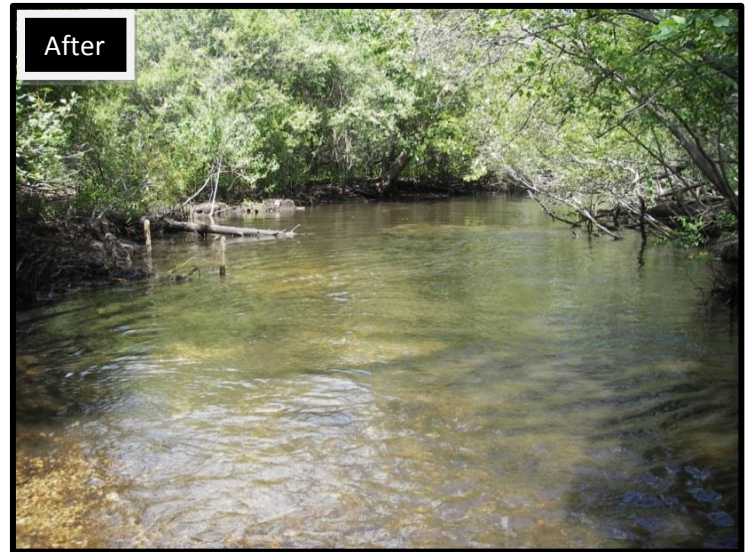
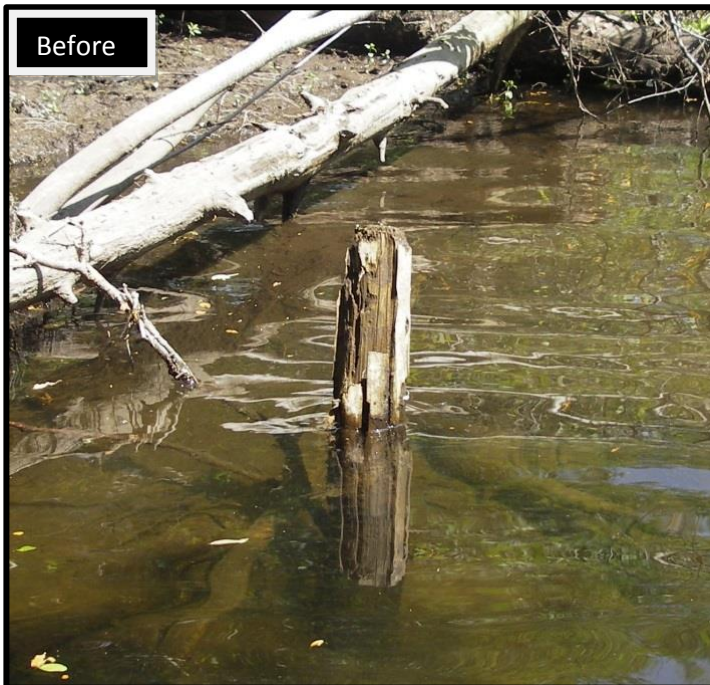
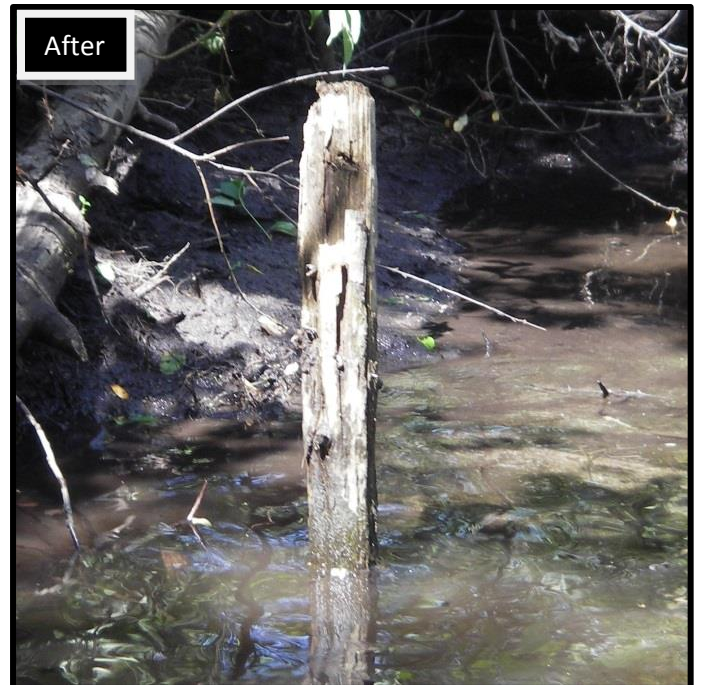
It took 2 days to remove the dam completely. The first day 50% of the material was removed and the crew had to make sure to do so evenly across the top of the dam to prevent a failure. A week later, the Rangers returned when the water levels had dropped which allowed the removal of the remainder of the dam. Most of the sticks were intricately woven together and it was quite difficult to dismantle. The sticks were displaced up on shore away from the dam location so it would not be easy for a beaver to resemble.

Photo 39 - Stream flowing freely after removal of beaver dam

Photo 40 - Water level surface with dam present

Photo 41 - Water level surface with dam removed

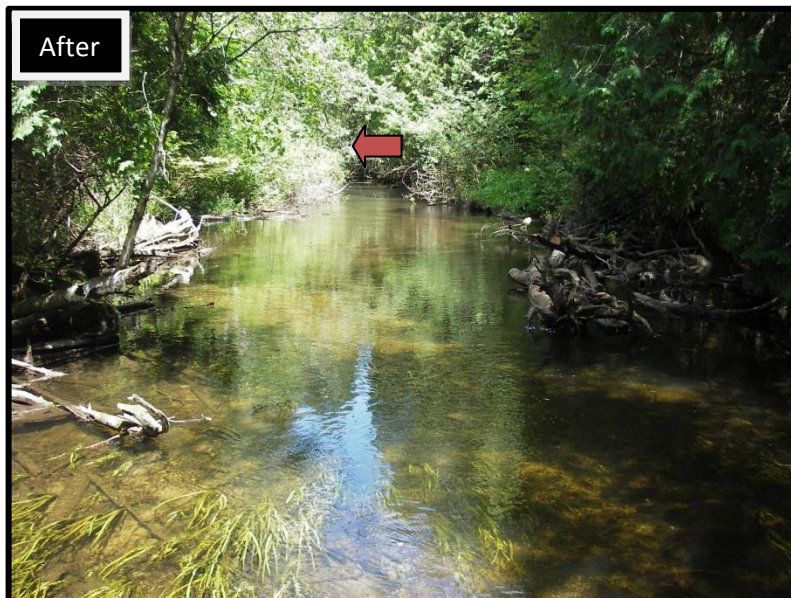
Debris removal and habitat improvements were also assessed downstream of the dam. A smaller debris pile was dismantled and rearranged towards the right hand side of the stream. This allowed sediment to be carried downstream and the new structure provided habitat.

Photo 43 - Debris pile removed, re-used to build structure to the right (in shadows)

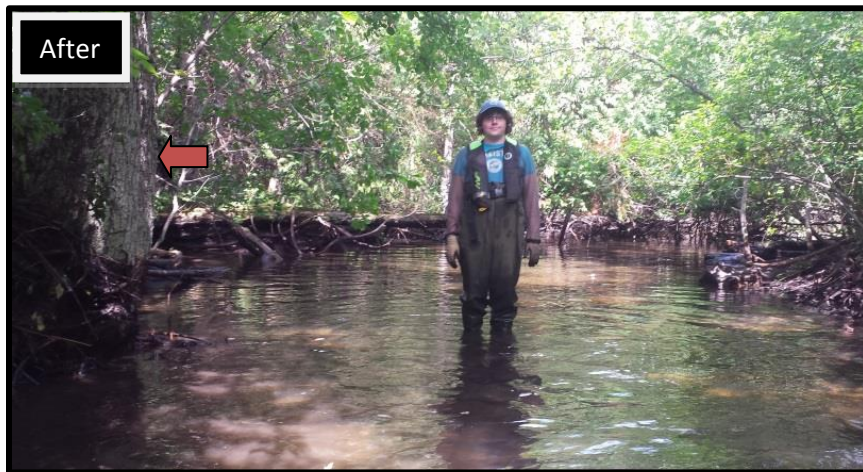
Photo 45 - Water levels following removal of beaver dam

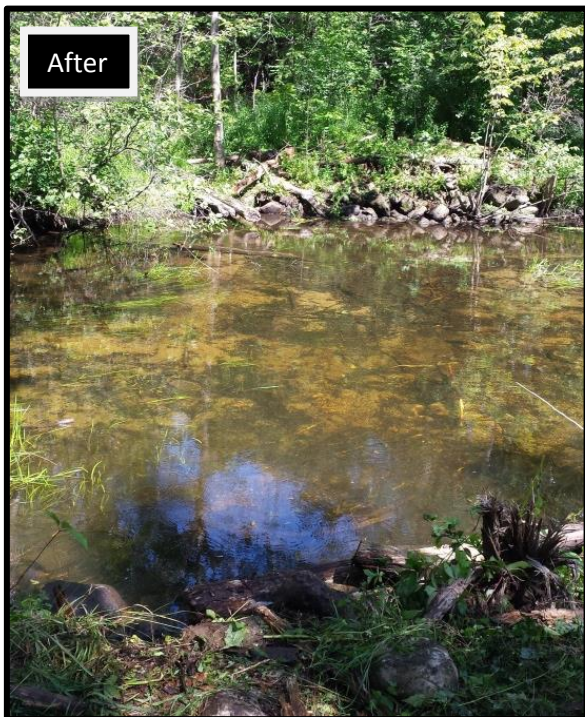
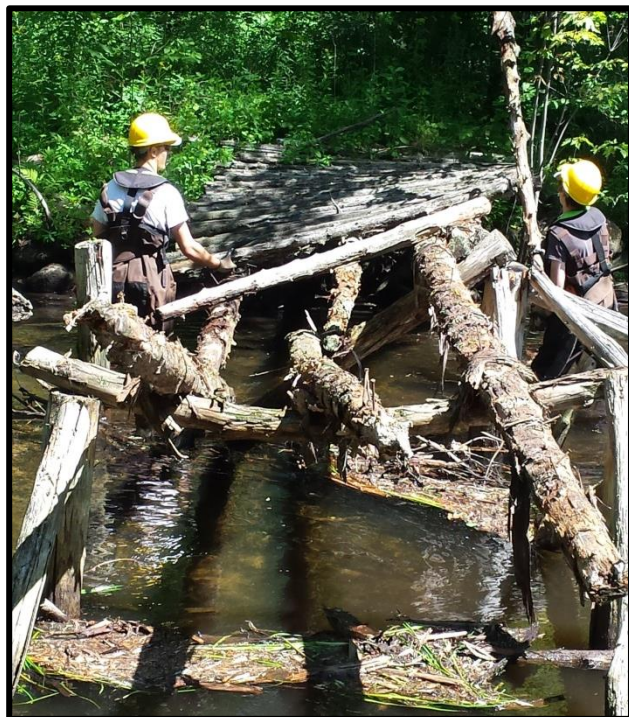
A total of 1½ days were spent at this property removing woody debris. The first task was to remove an old bridge from the stream because it was obstructing stream flow and was a potential source of further debris. Most of the cedar logs used on the top of the bridge were easily removed and piled up on shore. The remaining structural frame was built out of some very large logs and it required the whole crew to carry them up onto the shore. Upstream of the bridge, a large tree had fallen into the creek. To prevent excess widening of the creek, the tree was cut apart using hand saws and redistributed along the shoreline to enhance habitat.

Photo 47 - Channel free of obstruction

Photo 48 - Rangers removing bridge

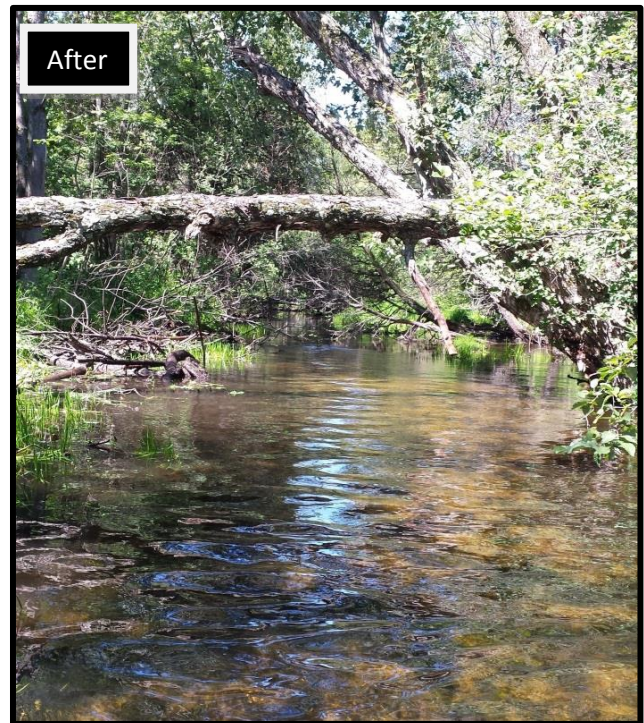
Photo 50 - Channel flowing freely
